**CWA COMPLIANCE EVALUATION INSPECTION REPORT
U.S. ENVIRONMENTAL PROTECTION AGENCY, REGION 5**

Purpose: Compliance Evaluation Inspection

Facility: FOIA Ex 6 Enterprises, LLC

Date of Inspection: September 19-20, 2018

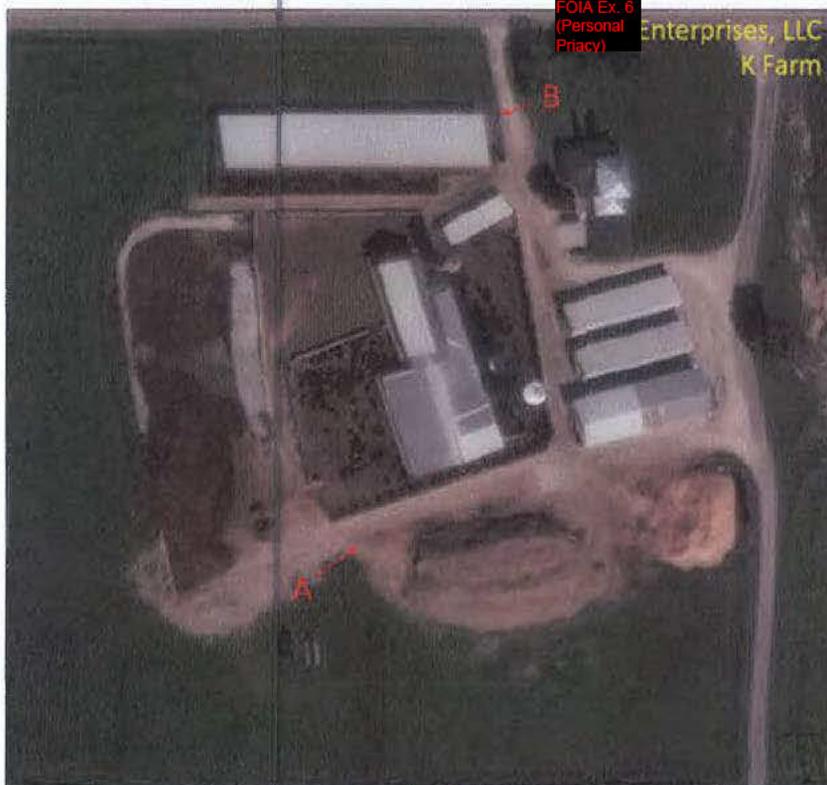
Figure 1: Aerial photograph of FOIA Ex. 6 Enterprises, LLC K Farm with Field Points.

Solid manure and used bedding were stacked at the south end of the Runoff Collection Pond on concrete that drains into the Runoff Collection Pond (Attachment 2: RIMG0404). Depth markers were present at the north end of the Runoff Collection Pond (Attachment 2: RIMG0405). Runoff from the open lots entered the Runoff Collection Pond at the northeast end (Attachment 2: RIMG0406). I observed excessive vegetation around the perimeter of the Runoff Collection Pond (Attachment 2: RIMG0407). WDNR received a complaint in December 2017 regarding liquid manure observed at the northwest end of the northern most barn and continuing to the road ditch. I observed this area during the inspection and did not see any remnants of manure. I did not observe any seepages out of the northwest end of the barn. EPA walked east along the northern end

of this barn. At Field Point B in Figure 1, I observed that a portion of the open lot at the northeast end of the barn may have the ability to runoff into a grassed area; however, no flow was observed at the time of the inspection (Attachment 2: RIMG0408). The walkthrough concluded at this site at approximately 4:00 p.m.

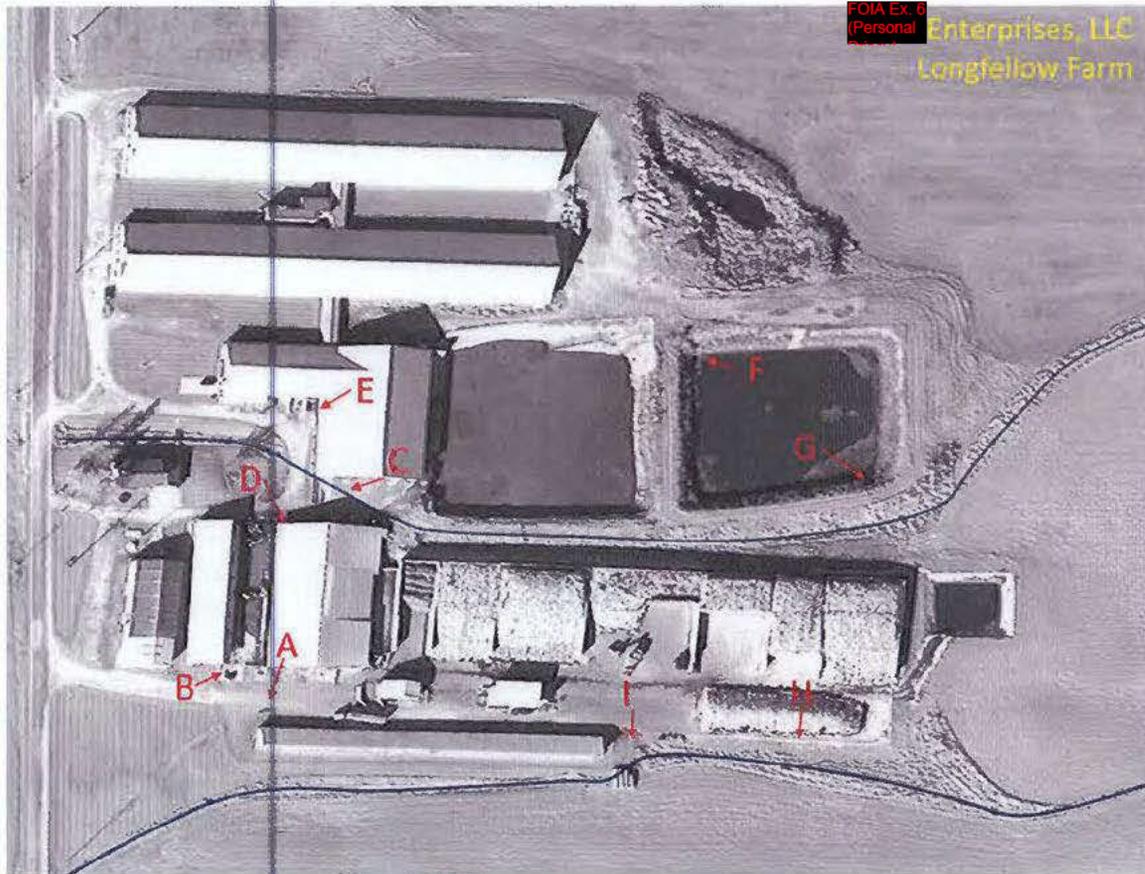
Figure 2: Aerial photograph of Enterprises, LLC Longfellow Farm with Field Points.

I observed that the tributary was dry where it passed through the facility at a culvert (Attachment 2: RIMG0438). At Field Point E in Figure 2, at the corner of the Special Needs Freestall Barn and the Milking Parlor, there was a staging area where manure and wastewater was exposed to precipitation. This area could potentially flow southwest to the tributary (Attachment 2: RIMG0439). Mortalities are temporarily kept in an adjacent area to the east. I observed bones on the ground in this area and a 55-gallon drum with garbage and a green liquid (Attachment 2: RIMG0440-RIMG0441). I observed waste feed on the ground on the south side of the milking parlor (Attachment 2: RIMG0442).

At Field Point F in Figure 2, I observed tire marks extending down the sideslope of the berm at the northwest corner of the WSP #2 (Attachment 2: RIMG0452-RIMG0453). At Field Point G in Figure 2, I observed the concrete outfall was being undercut at the southeast corner of WSP 2 by erosion of the berm (Attachment 2: RIMG0454-RIMG0455). We walked back to the south end of the site. At Field Point H in Figure 2, I observed that a portion of the concrete feed storage area was sloped such that wastewater was flowing off the southern end into a grassed area (Attachment 2:

RIMG0457). I observed that the wastewater had killed vegetation at the point where it flowed off the concrete and dead vegetation was observed approximately 10 feet into the grassed area (Attachment 2: RIMG0458-RIMG0459). This area ultimately drains the the tributary that is adjacent to the south end end of the site. At Field Point I in Figure 2, I observed feed solids on the ground in the south end of the feed storage area that could drain southeast into a grassed area (Attachment 2: RIMG0460-RIMG0461). I observed feed solids along the southern end of the barn on the south end of the site in areas that could drain to the tributary (Attachment 2: RIMG0462).

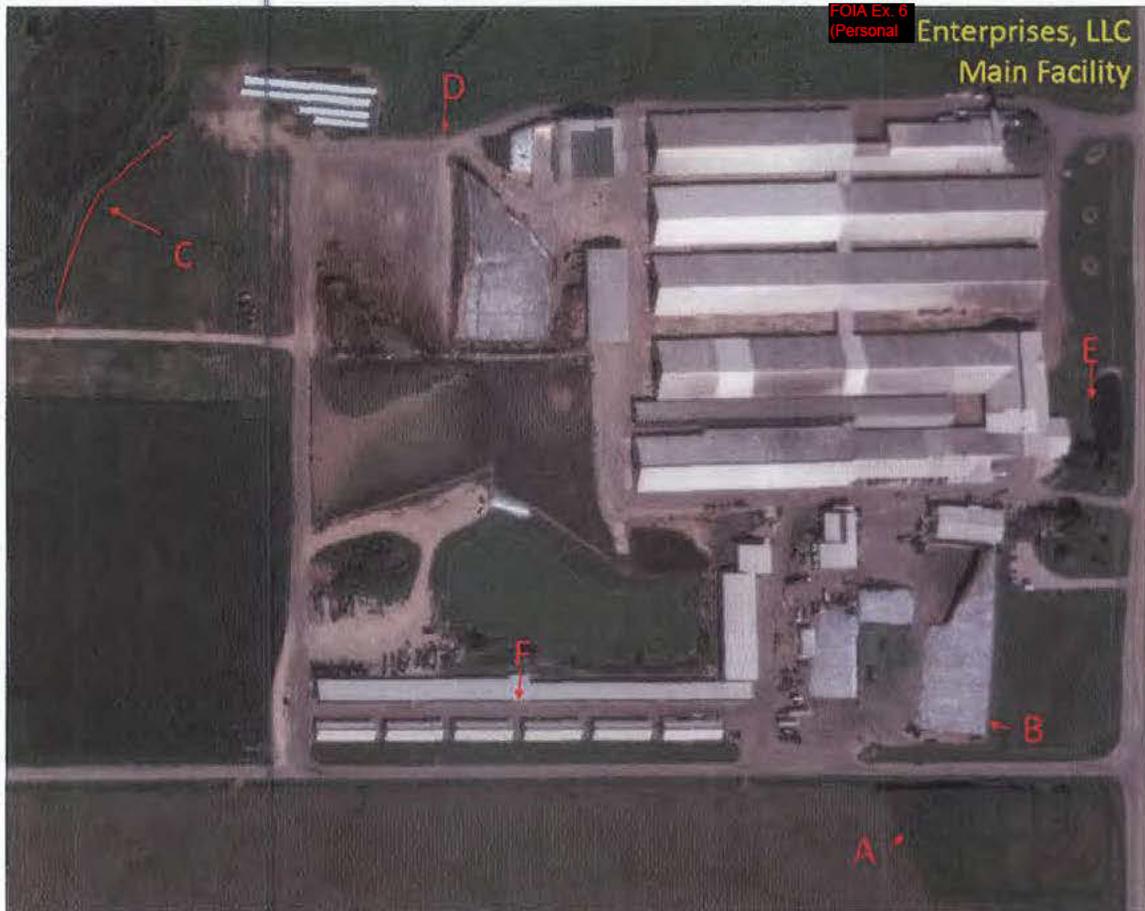
Figure 3: Aerial photograph of FOIA Ex. 6 Enterprises, LLC Main Facility with Field Points.

We continued west along the south end of the Main Facility. At Field Point B in Figure 3, I observed some dead vegetation on the southeast end of the bunkers likely due to bunkers releasing leachate (Attachment 2: RIMG0470). We walked to the east end of the calf and heifer barns and then continued north. The farm lane between the calf and heifer barns drains from west to east into a stormwater inlet that outlets to the pond at the center of the facility (Attachment 2: RIMG0471). Stormwater piping was observed northwest of the feed storage area (Attachment 2: RIMG0472). I observed a small amount of sheen on the water surface that drained to the stormwater inlet (Attachment 2: RIMG0473).

Earthmoving had started at the west end of the Main site (Attachment 2: RIMG0483). I observed a broken silt fence post (Attachment 2: RIMG0484). Field Point C in Figure 3 is the approximate location of the silt fence. In many locations the bottom of the silt fence had not been dug in properly (Attachment 2: RIMG0485-RIMG0486). I observed that silt fence posts had not been installed properly because silt fence post ends had not

We walked east along the north end of the facility. At Field Point D in Figure 3, along the north end of the feed storage area, I observed feed solids blown into the field (Attachment 2: RIMG0490). I observed water with a brownish color in the field north of the feed storage area (Attachment 2: RIMG0491). Further east, I observed that the fans blowing out of Freestall Barn #5, northernmost barn, were depositing solids on the asphalt which drains to a storm water inlet (Attachment 2: RIMG0493). A stormwater inlet was located between barns (Attachment 2: RIMG0494). At Field Point E in Figure 3, I observed water that was light brown in color discharging from the storm water pipe into the pond on the east end of the facility (Attachment 2: RIMG0495). The final disposition of the stormwater pond was unknown (Attachment 2: RIMG0496). At the closing conference, Ex. 6 (Personal Privacy) stated that if the stormwater pond filled enough that it could flow south along the road ditch.

from west to east (Attachment 2: RIMG0499). At Field Point F in Figure 3, I observed track out of manure at the heifer barns which would flow with stormwater to the east (Attachment 2: RIMG0500). I observed that the stormwater flows east to a stormwater inlet and outlets into the center storm water pond (Attachment 2: RIMG0500-RIMG0501). I observed the stormwater outlets at the southwest corner of the stormwater pond (Attachment 2: RIMG0502). The final disposition of the pond is unknown. There were no managed outfalls. The inspection walkthrough concluded at 11:00 a.m.

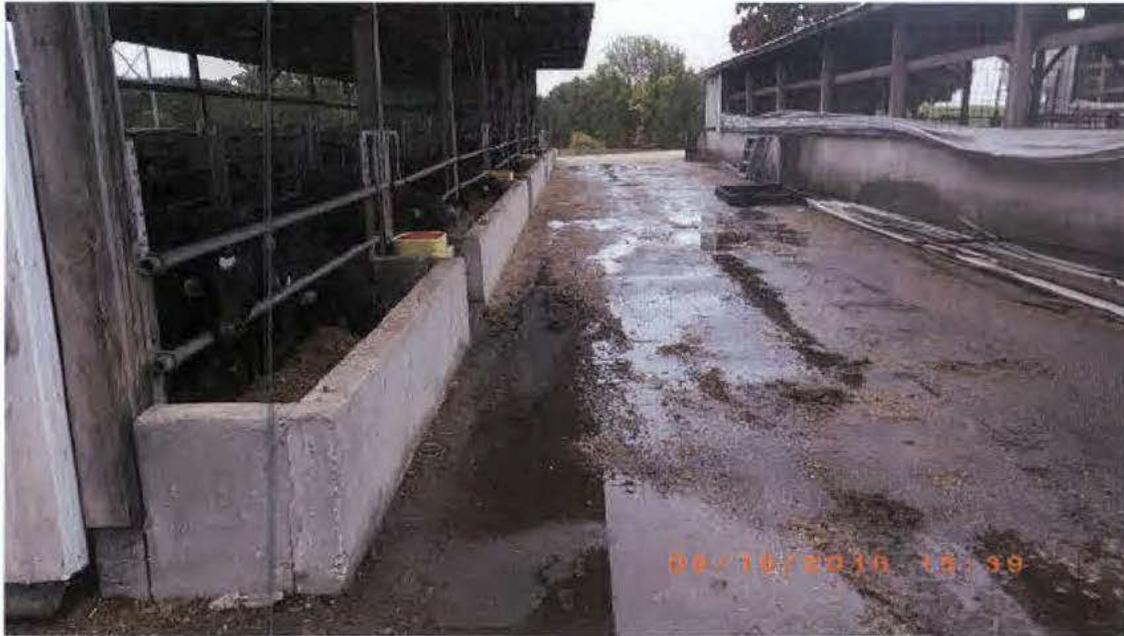
3: RIMG0398

Description: The lane between barns was sloped from east to west.

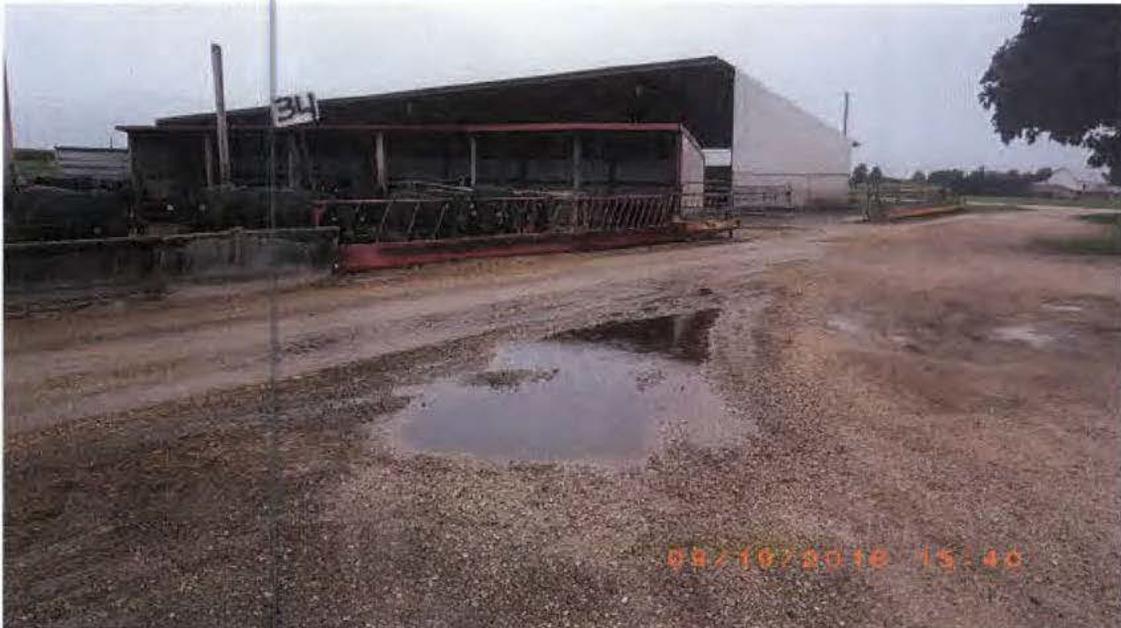
4: RIMG0399

Description: I observed ponded water along farm access road. Cattle feed can be seen on the ground throughout the photo.

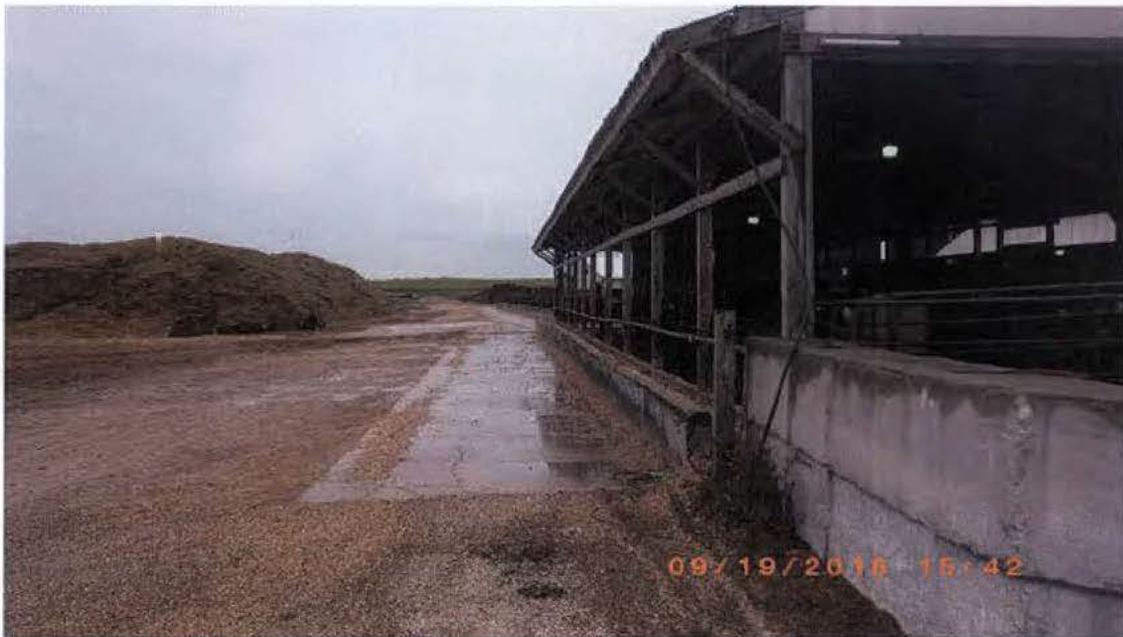
6: RIMG0401

Description: The south side of the barns drains to the west.

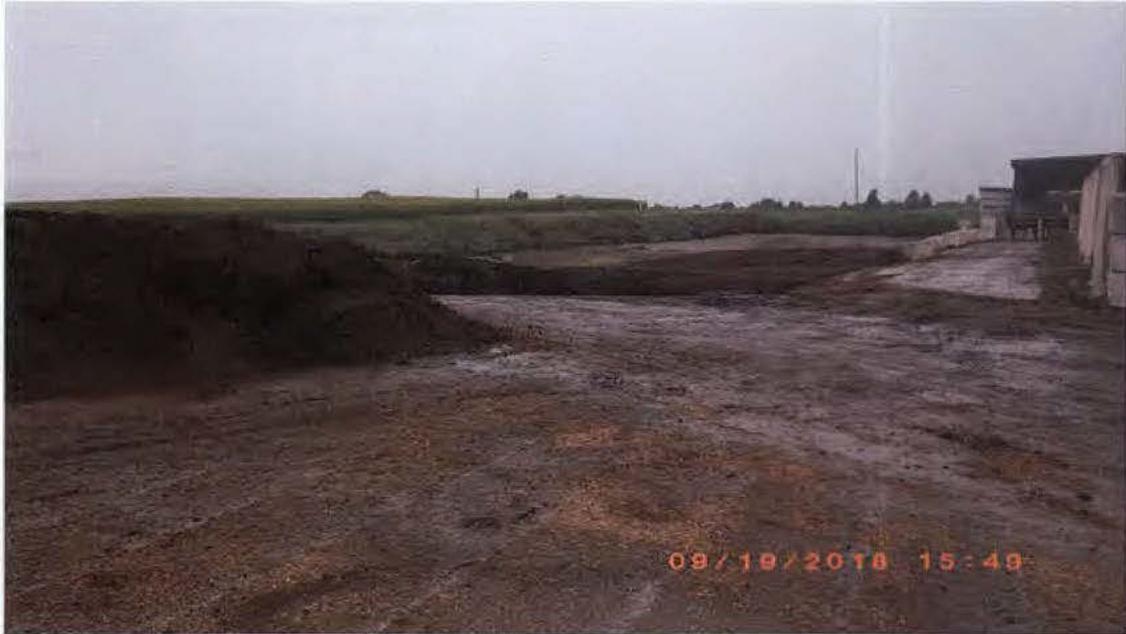
9: RIMG0404

Description: Manure solids that are stacked on the south side of the Runoff Collection Pond drain into the pond.

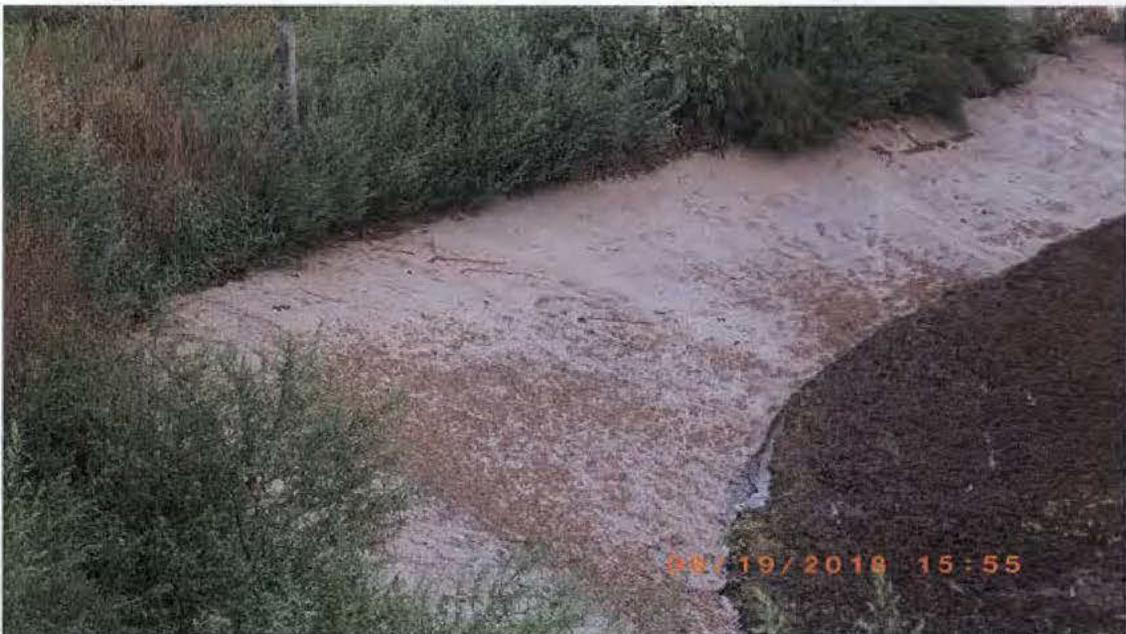
10: RIMG0405

Description: Depth markers were located on the north end of Runoff Collection Pond.

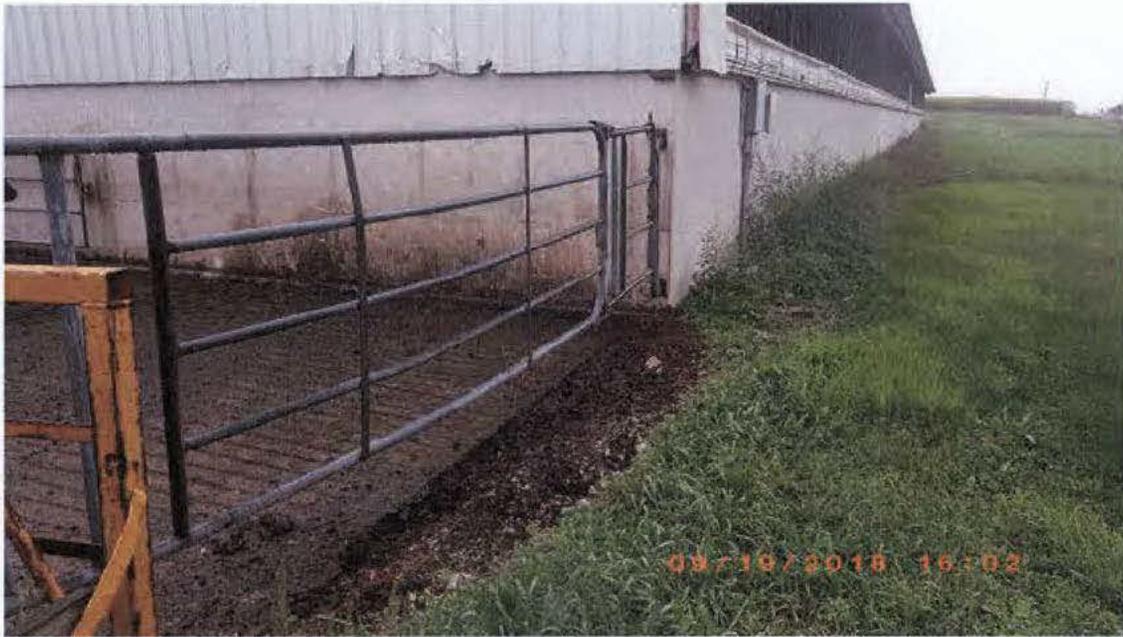
13: RIMG0408

Description: The north edge of the cattle lot contained some dug in areas where cattle foot traffic had occurred and runoff could potentially flow north.

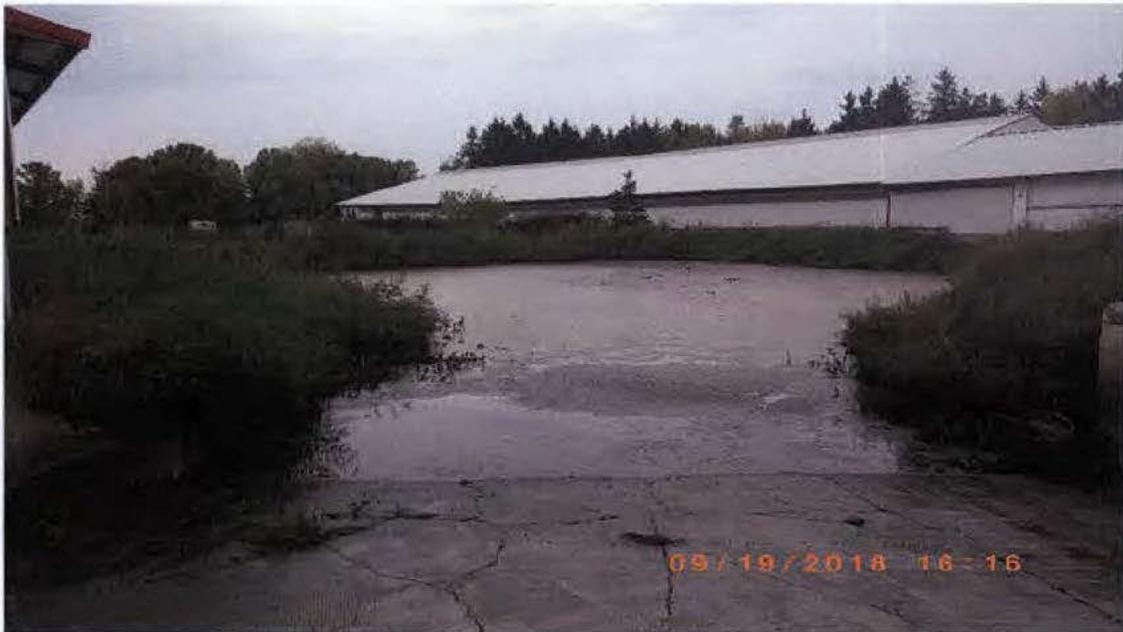
14: RIMG0409

Description: The WSPs at the S Farm were used for remote storage of manure. Cattle were not present at the site. Excessive vegetation was observed along the berms. Trees had become established between the two WSPs.

- Excessive vegetation was observed around the Runoff Collection Pond (K Farm).
- Excessive vegetation was observed around the WSP #1 (S Farm) and WSP #2 (S Farm) and trees where growing on the WSP berm.

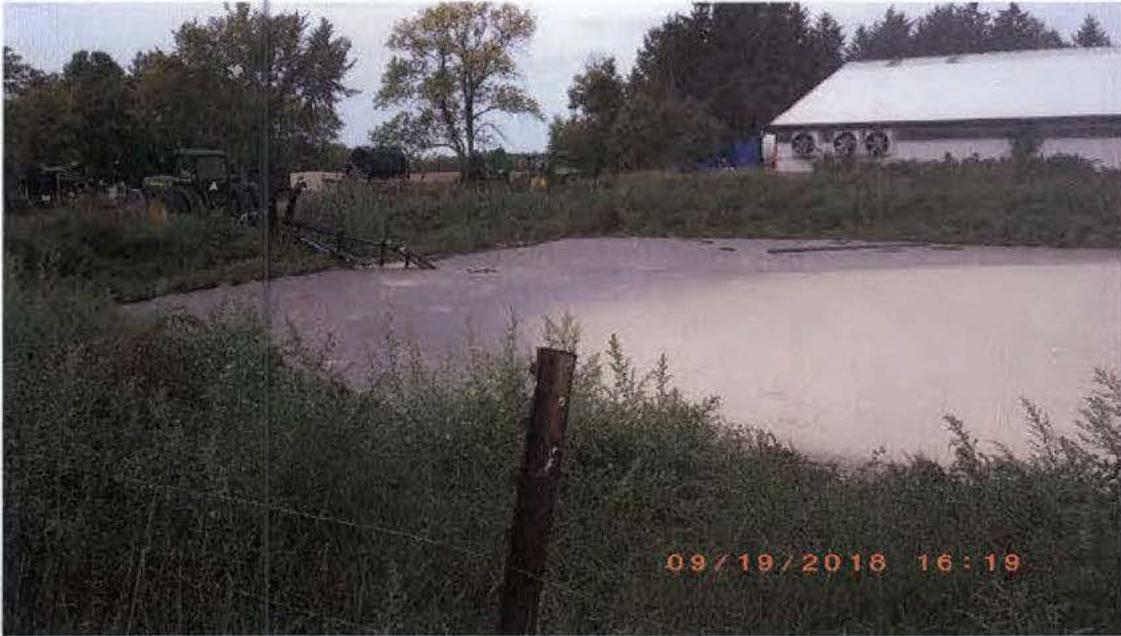
15: RIMG0410

Description: The WSPs at the S Farm were used for remote storage of manure. Excessive vegetation was observed along the berms.

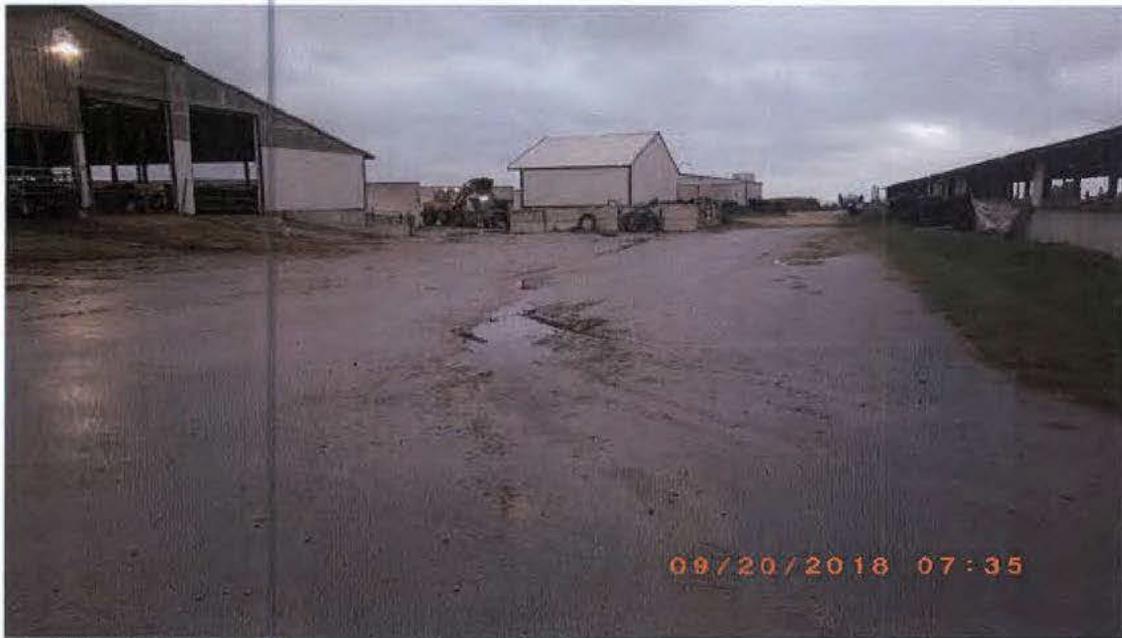
20: RIMG0415

Description: Portions of the farm road on the southwest end of the facility drain to the southwest. Track out of manure and feed was observed near the barn accessway. The water was observed flowing southwest off the farm road and had a brown tint.

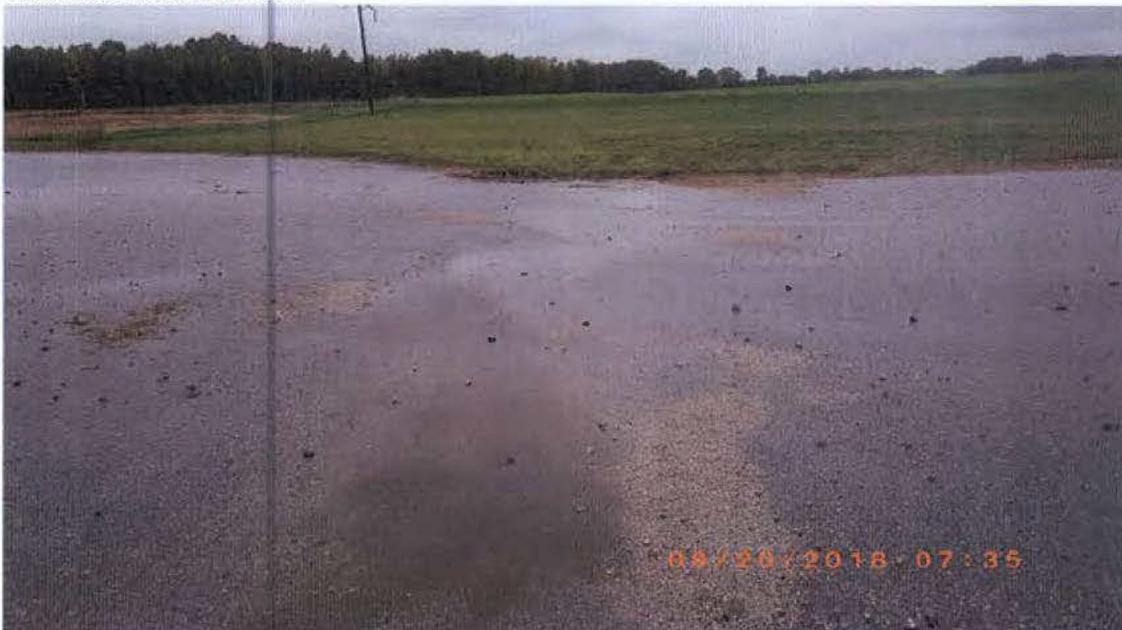
21: RIMG0416

Description: The water was observed flowing southwest off the farm road and had a brown tint. The water dissipated as it entered the grassed area and flow was not observed continuing toward a tributary south of the facility.

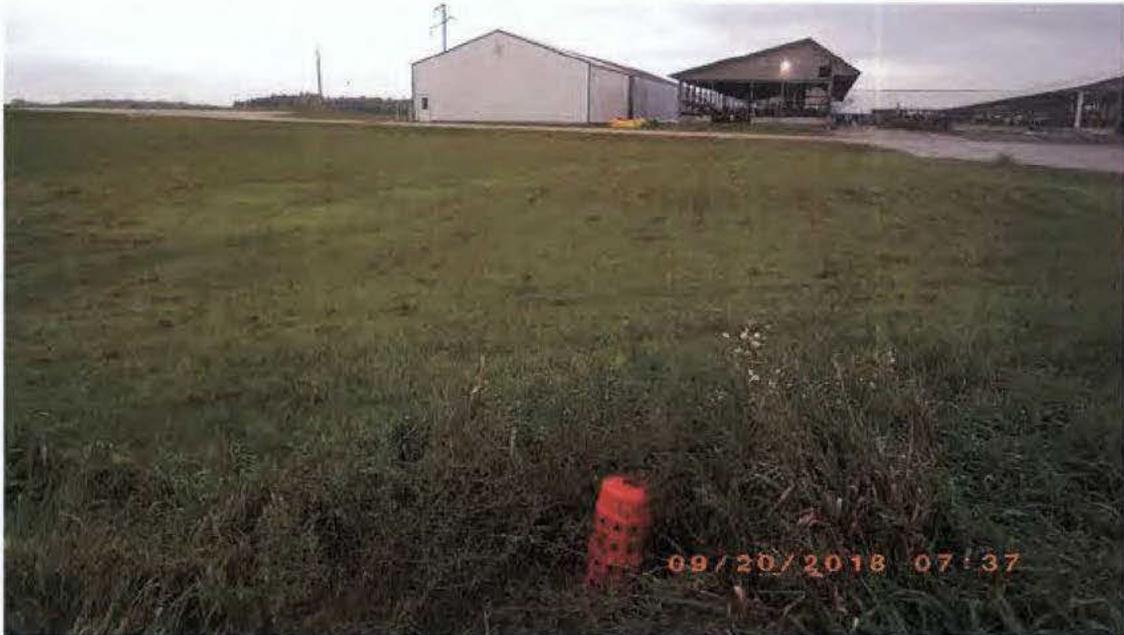
22: RIMG0417

Description: A tile riser was located at the southwest end of the site. If a significant enough of a rainfall occurred this area would drain the area documented in RIMG0415-RIMG0416.

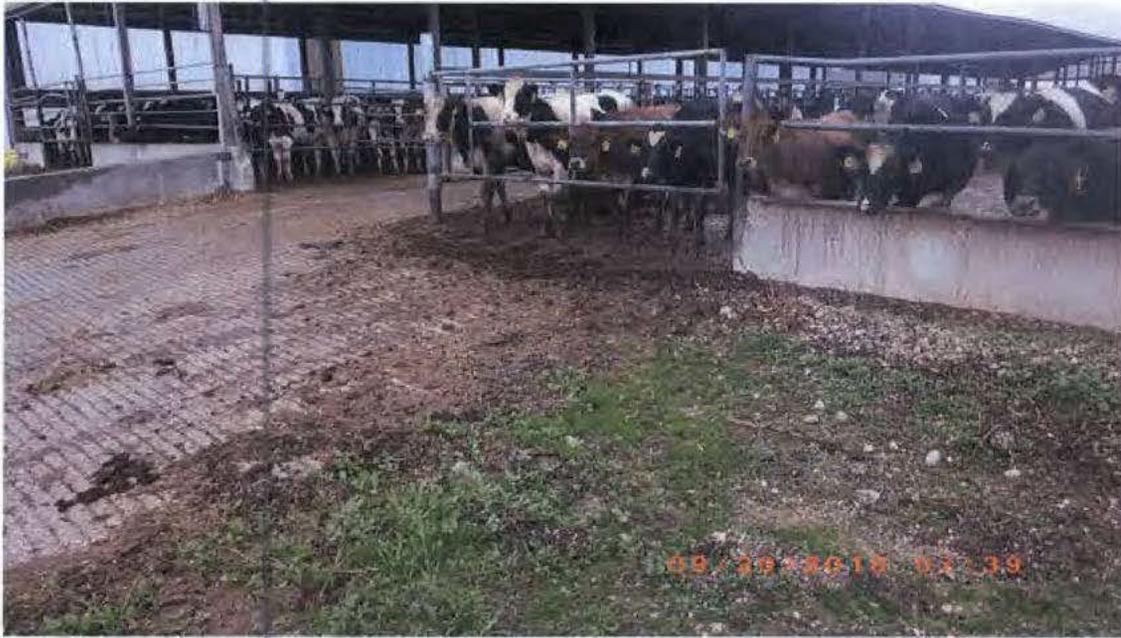
24: RIMG0419

- At the Longfellow Farm, at Field Point A and B, track out of manure was observed as the south end of the open lot and barn and was draining with storm water to the southwest into a grassed area.

Description: Track out of manure was observed at the south end of the open lot which could drain south.

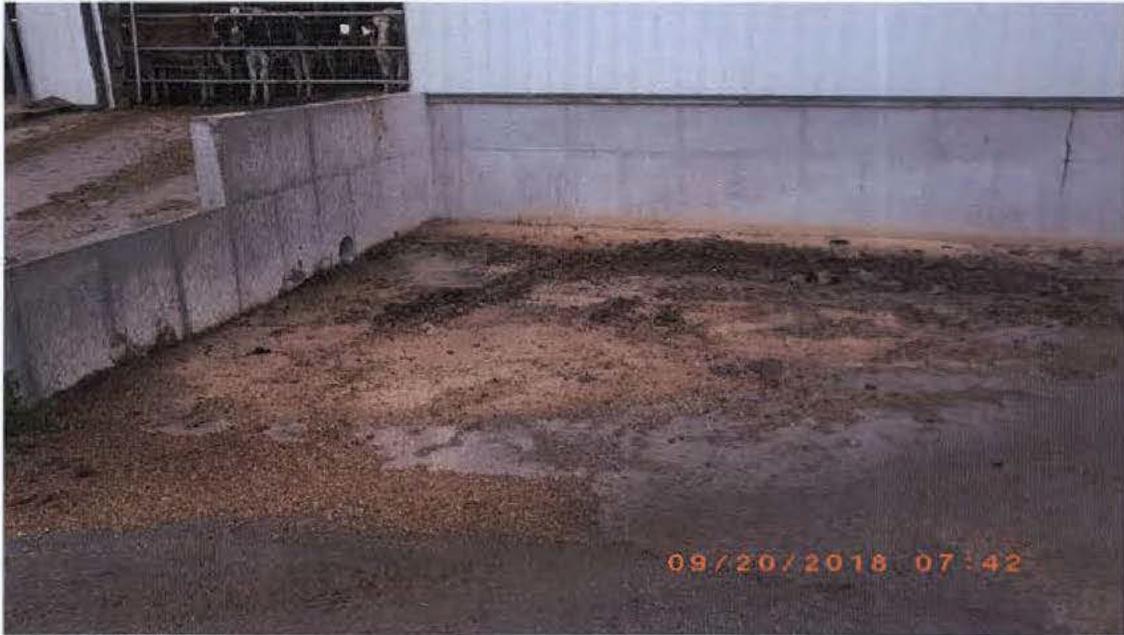
26: RIMG0421

Description: The outlet from the open lot catch basin flows to the east.

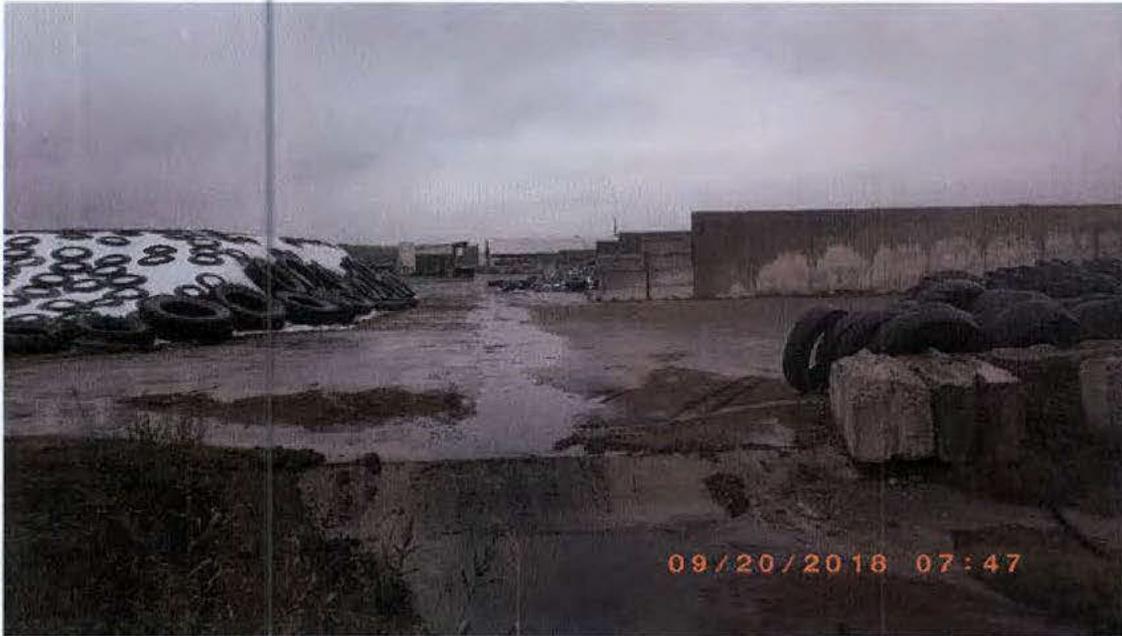
28: RIMG0423

Description: Surface runoff from the feed storage and open lot flows to the east toward a ditch and the Leachate Basin.

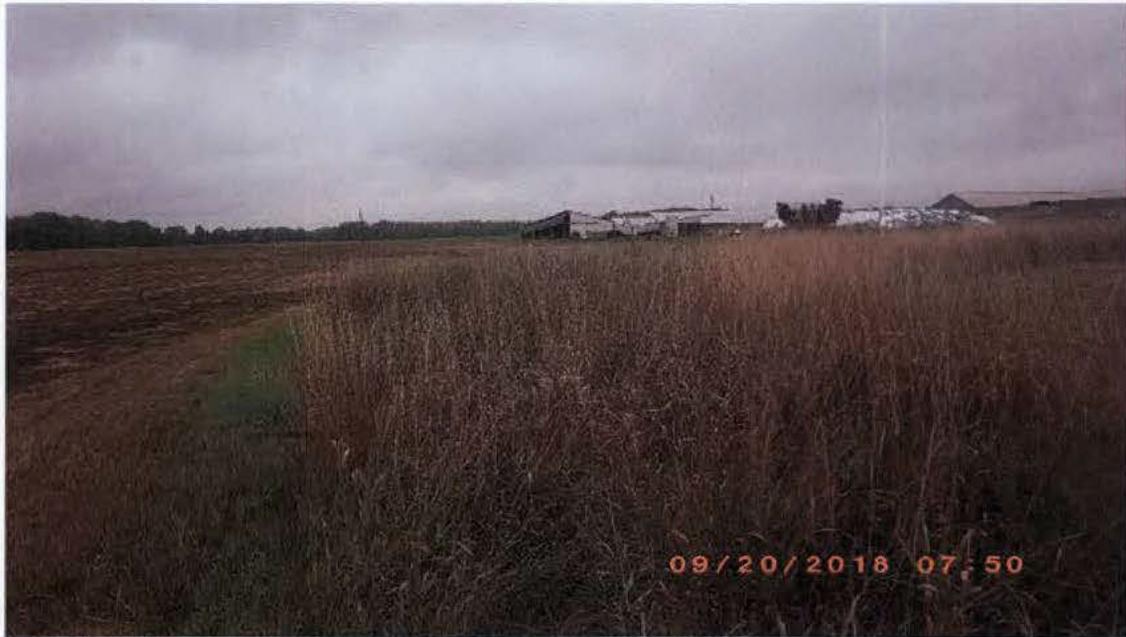
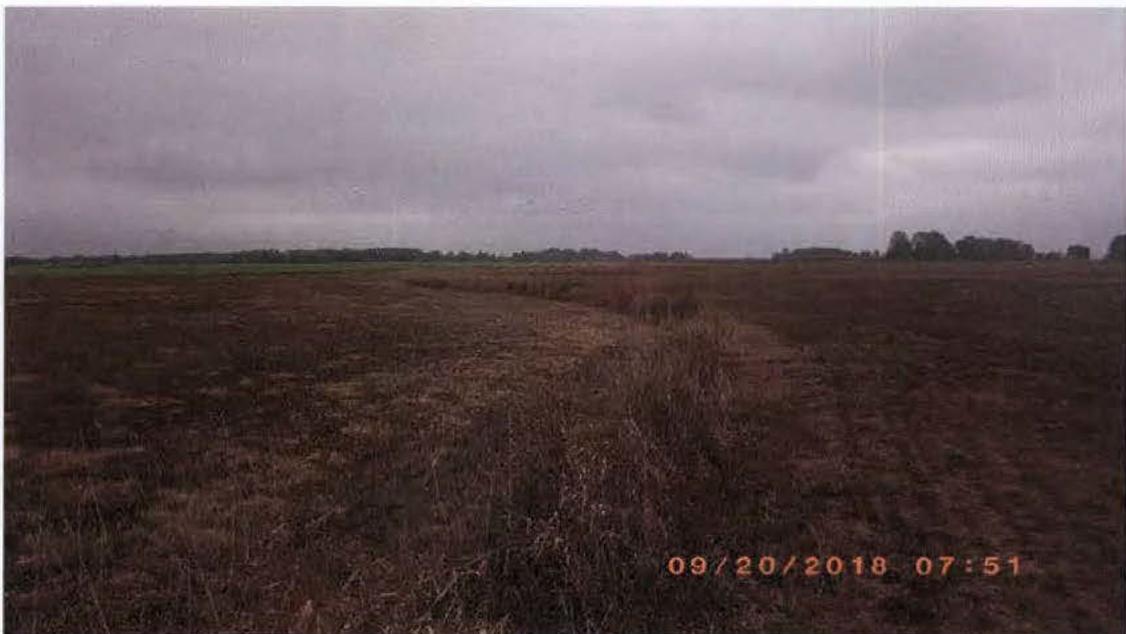
Description: The grassed tributary did not have water in it and was not flowing at the time of the inspection.

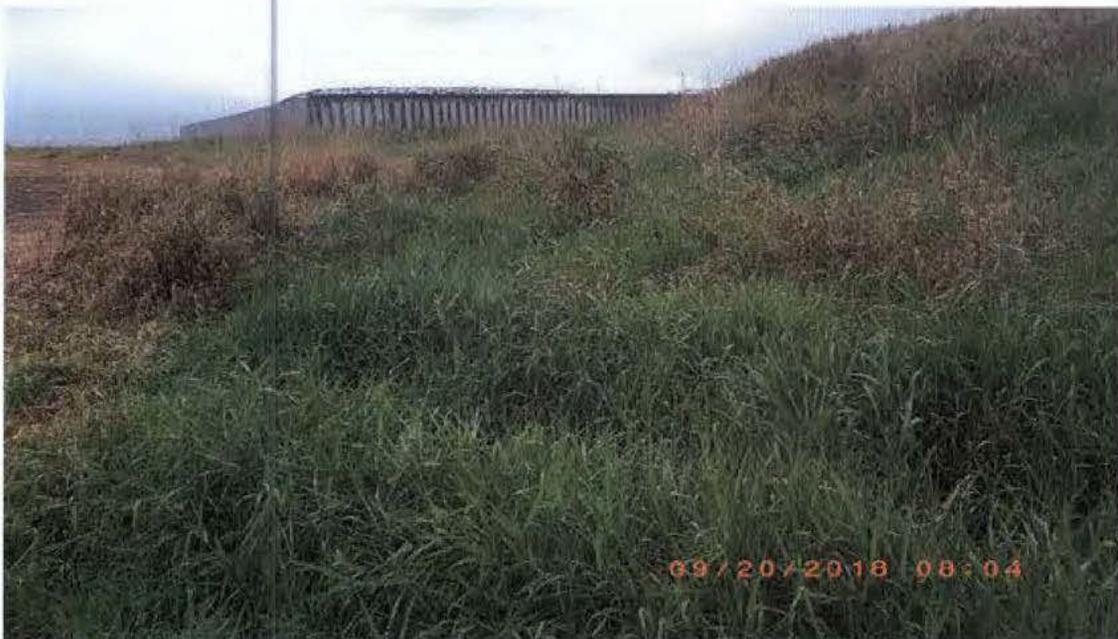
32: RIMG0427

Description: The tributary that flows through the facility did not have water in it and was not flowing at the time of the inspection.

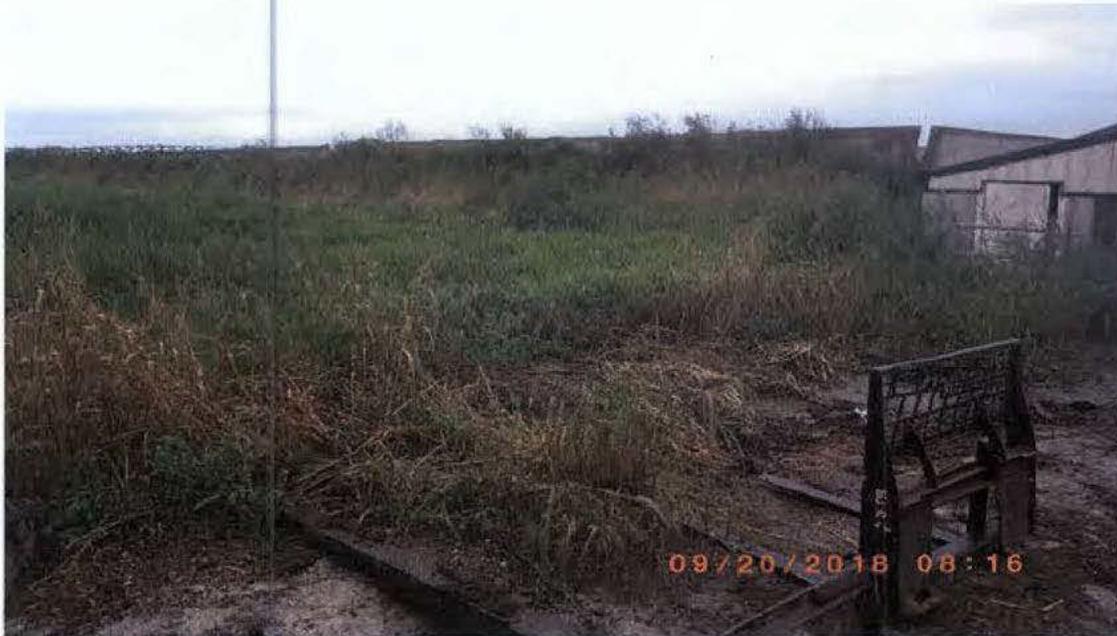
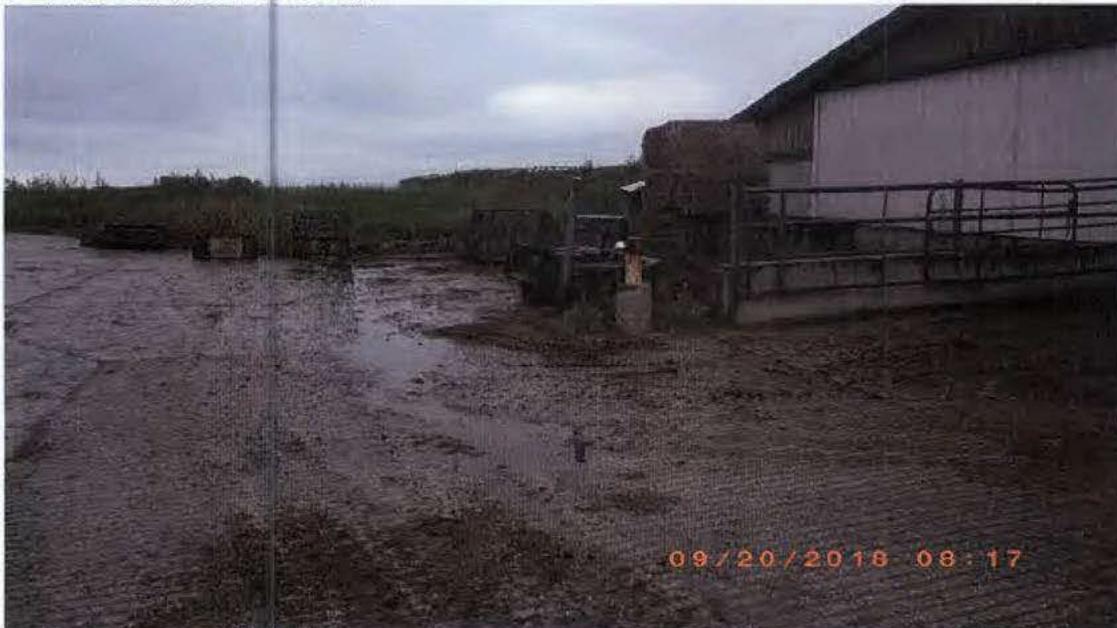
Description: Manure solids and feed was observed around an area between barns. This area drains to the waterway. It appeared that much of this waste was due to track out at the barns.

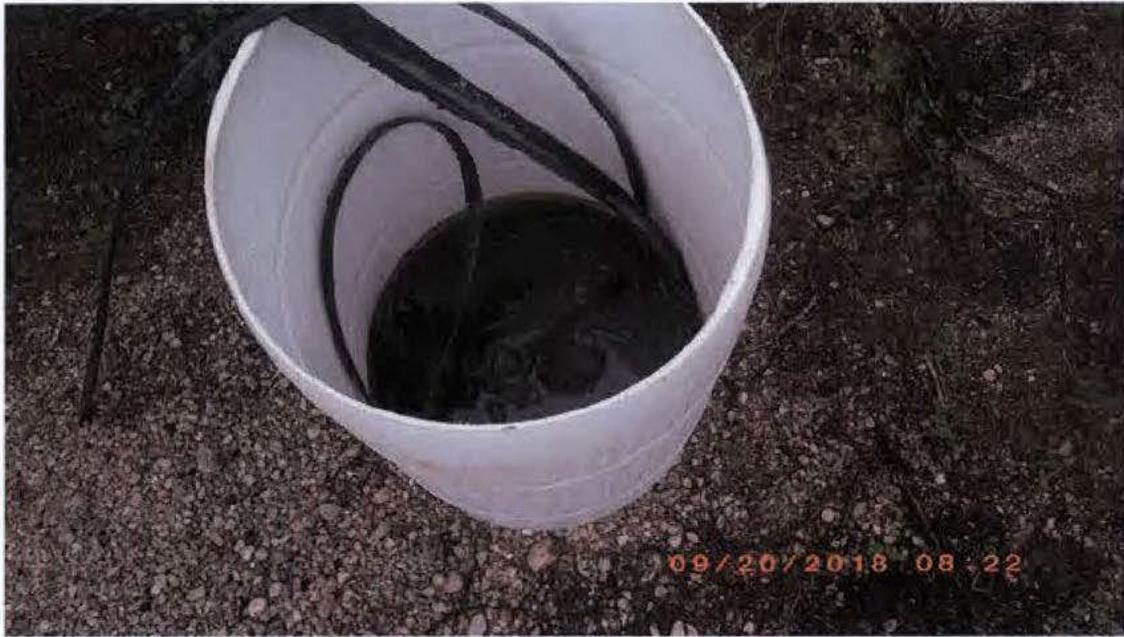
46: RIMG0441

Description: The 55-gallon drum contained a greenish liquid and contained some garbage.

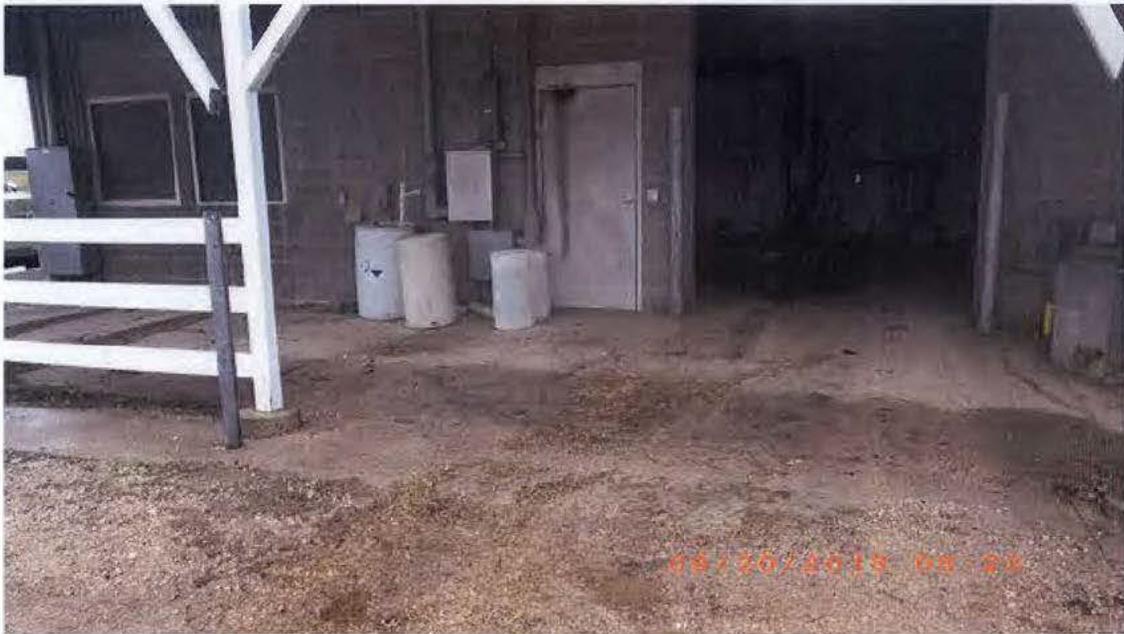
47: RIMG0442

Description: Track out of feed was observed near the milking parlor area. The puddle was a light brown in color.

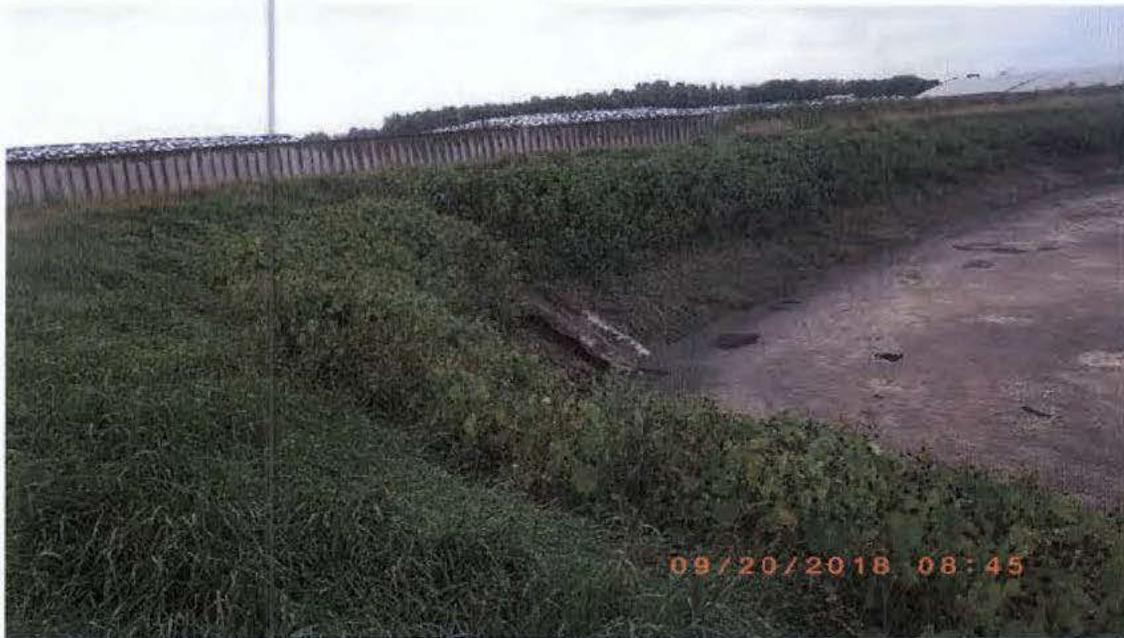
60: RIMG0455

Description: The concrete outfall was being undercut at the southeast corner of WSP #2.

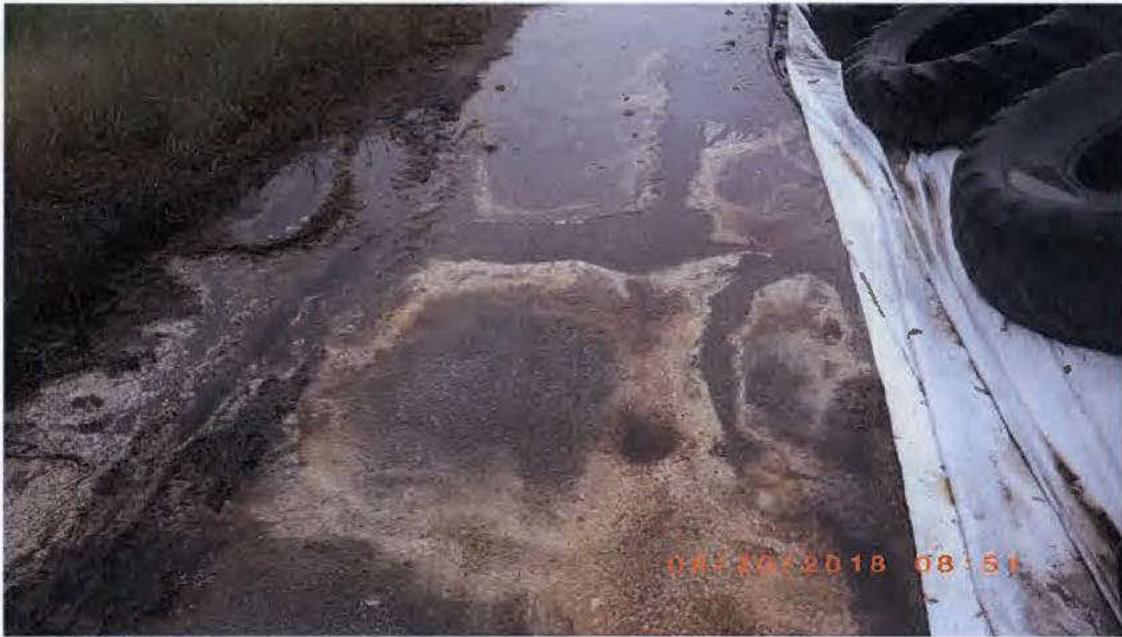
62: RIMG0457

- At the Longfellow Farm, at Field Point H, silage leachate was flowing off feed storage area toward a tributary to the south. A section of dead vegetation was observed in the pathway generated by the silage leachate.

Description: A portion of the concrete feed storage area was sloped such that wastewater was flowing off the southern end into a grassed area.
